Streambank Stabilization Program Update

Preliminary Open Meeting – February 12, 2024

Streambank Stabilization – Update

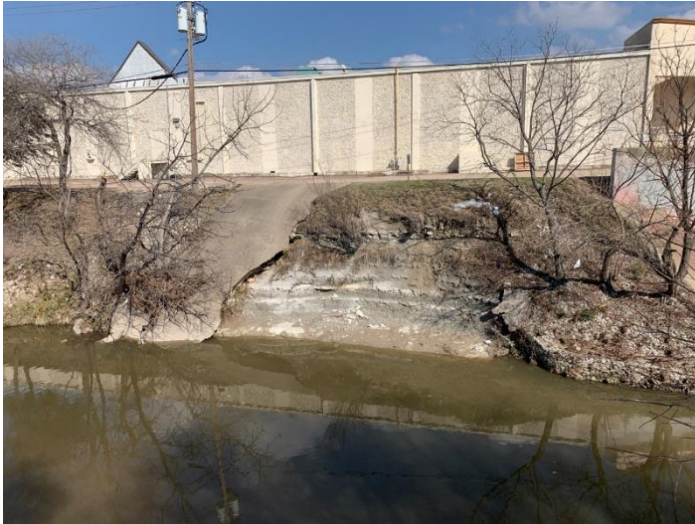
- Scoring – Lowest Score 7.5

- Structure failing
- erosion threat behind structure
- loss of back fill
- base undermined

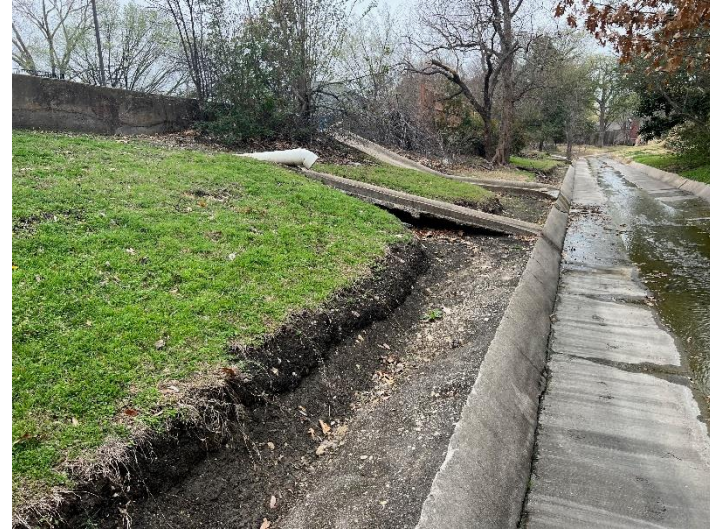
- Average Score – 67.5

- Medium Value Threat
- Failure in 3 to 5 yrs
- stable slope with vegetation
- no safety issues.

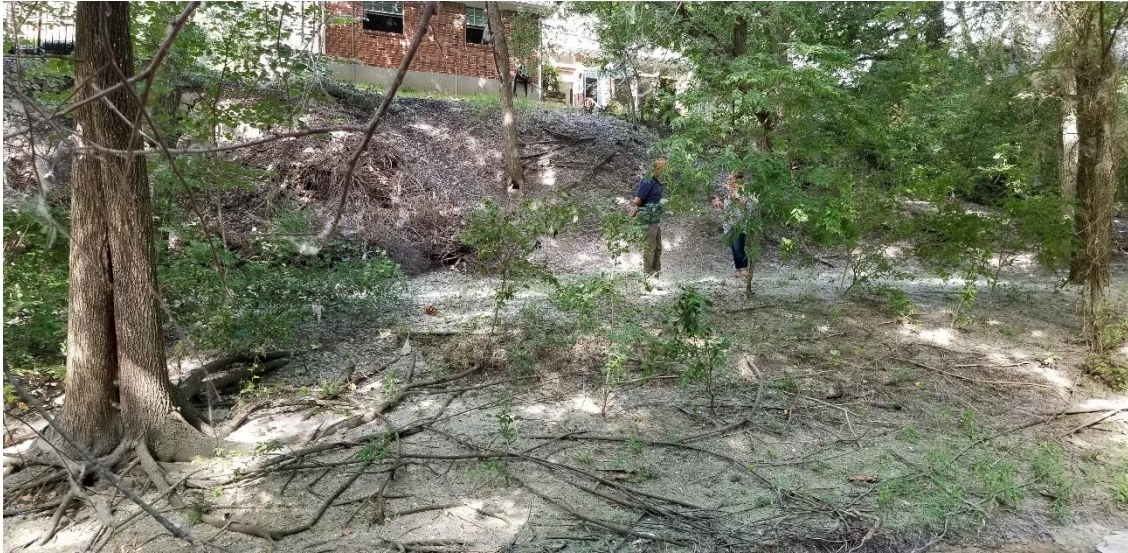
- Maintenance Requests – Waasland Drive

Maintenance Responsibility per Plat:
Property Owner

Property Evaluated on November 2,
2023. **Score – 71**

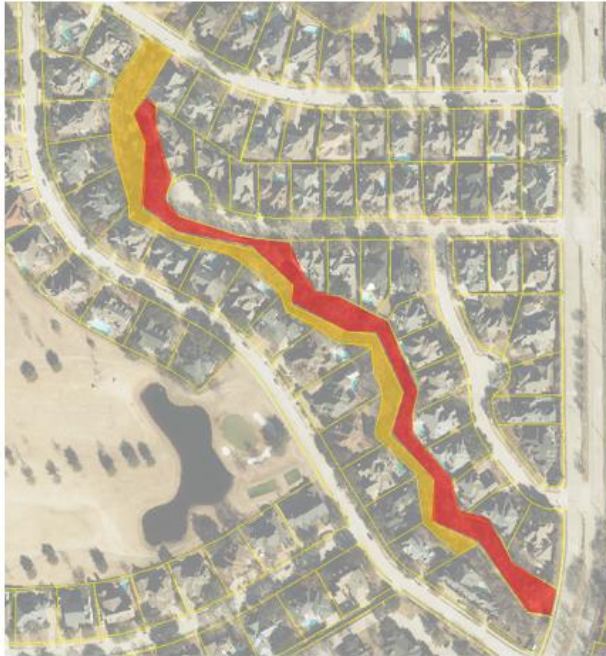
- Maintenance Requests – The Hills of Indian Creek

Maintenance Responsibility per Plat:
HOA and City

Evaluation has been Performed.

- **HOA Side - 41.25 to 93**
- **City Side – 43.75 to 78.75**
