# APPENDIX - RAIL CAR 360

## CURRENT CONDITIONS

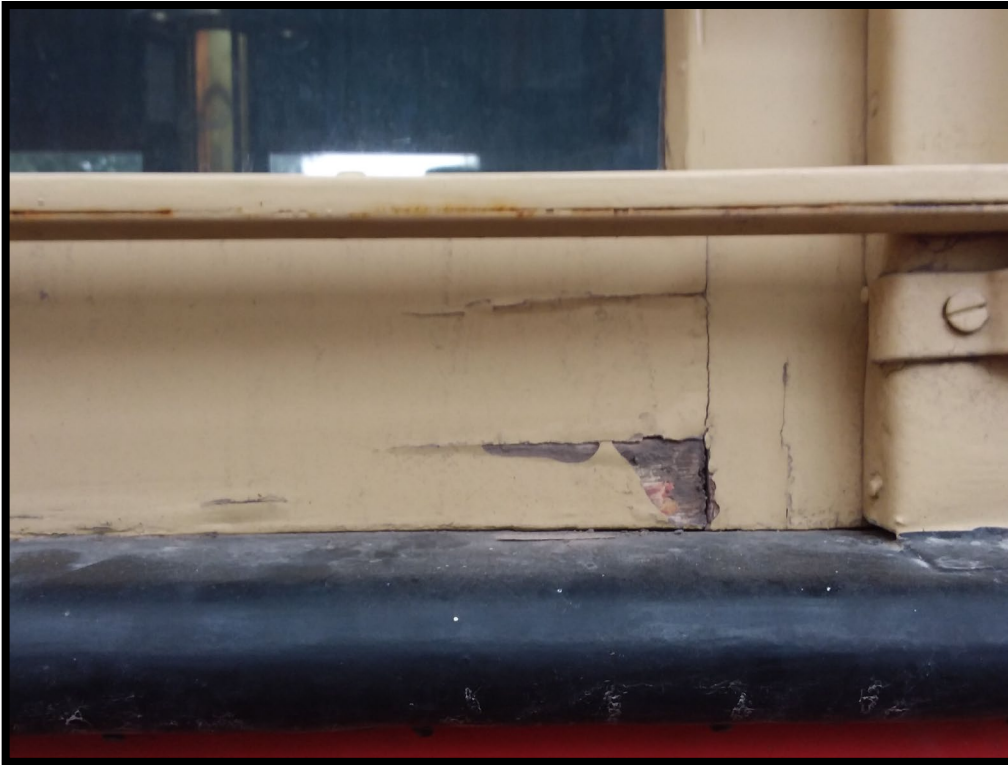
- Vertical members of the frame are called stiles while the horizontal members are known as rails.
- Over time the absorption of water has caused rot and paint degradation.
- All windows should be checked
