Streambank Stabilization Program Update

Preliminary Open Meeting – February 12, 2024

Streambank Stabilization – Update

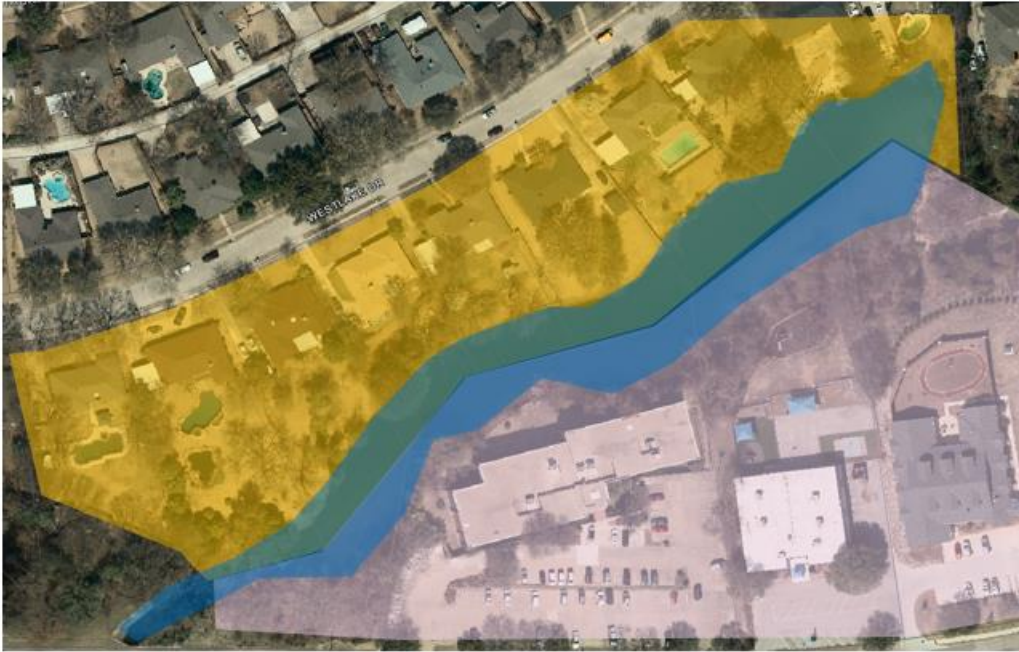
- Maintenance Requests – Westlake Pond

Maintenance Responsibility per Plat:

Residential – 9 Lots. Not Specified
Commercial – 4 Lots. Property Owner

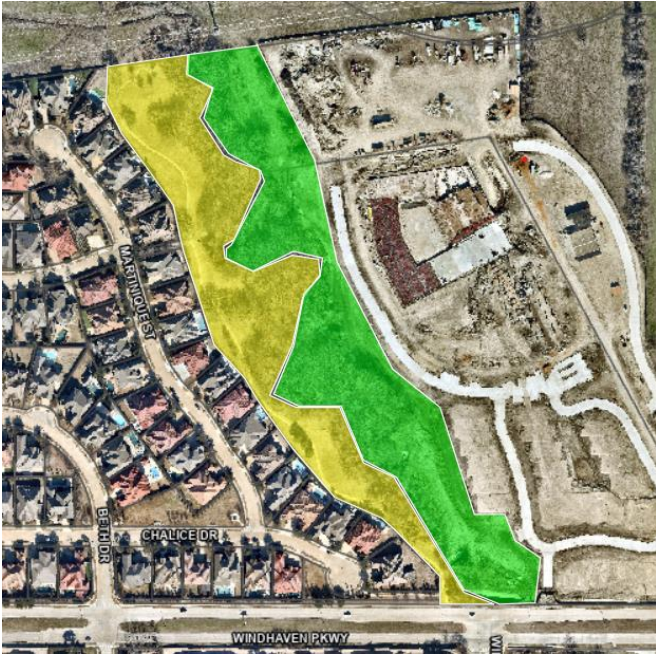
- Maintenance Requests – Avignon/The Outlook

Maintenance Responsibility per Plat:
HOA and City (Parks)

No Evaluation Performed to Date.

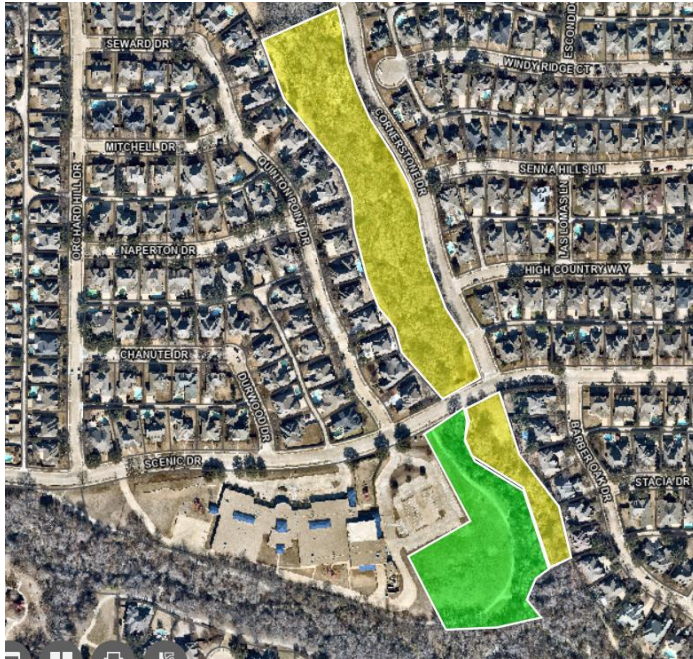
- Maintenance Requests – The Estates of Wooded Cove

Maintenance Responsibility per Plat:
HOAs (2) and City(Parks)

No Evaluation performed to date.
